TECHNICAL REPORT

REPORT NO: NAWCADPAX--98-8-TR

FIBER FINISHES FOR IMPROVING GALVANIC RESISTANCE OF IMIDE-BASED COMPOSITES

12 February 1998

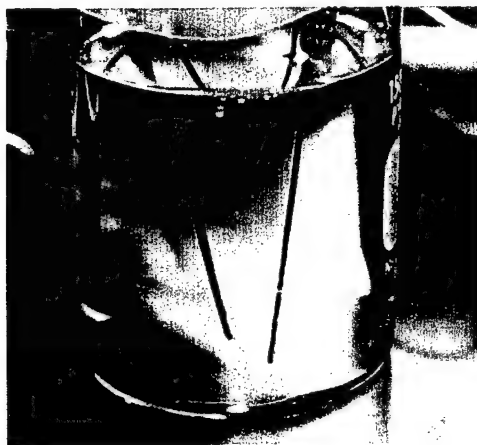
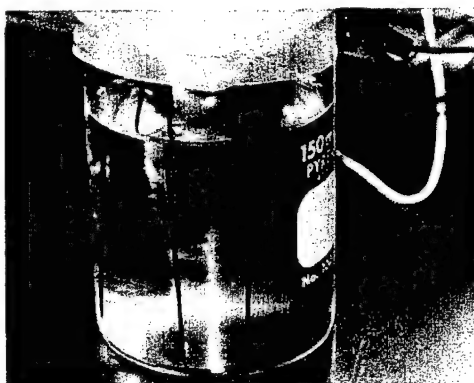
The second screening tests examined galvanic corrosion susceptibility. The appearance of the sample rods after 2 days of immersion is shown in Figure 24. Little aluminum corrosion product was seen with the PH9301F and PH9304F finishes shown in 24a and 24b. A small amount of corrosion product is seen with the PH9306F finish (24c) and a larger amount with the PH9305F finish (24d). The control samples (24e and f) exhibited a similar amount of corrosion product as the PH9305F sample. $Al(OH)_3$ is the expected corrosion product.

Figure 24. Galvanic corrosion samples after 2 days of immersion
